### ADDENDUM NO. 5 - OUTLINE AND SUMMARY INFORMATION

Project Name: MSU Barnard 111 – Lithography Lab  
Location: Montana State University - Bozeman  
Owner: State of Montana, MSU - Bozeman  
Plew Building 6<sup>th</sup> and Grant, PO Box 172760  
Bozeman, Montana 59717-2760

**SUBJECT: Pre-Renovation Asbestos Inspection Report**  
Rooms 110 and 111  
Barnard Hall  
Montana State University  
Bozeman, Montana  
Tetra Tech Project No. 117-001068-26002

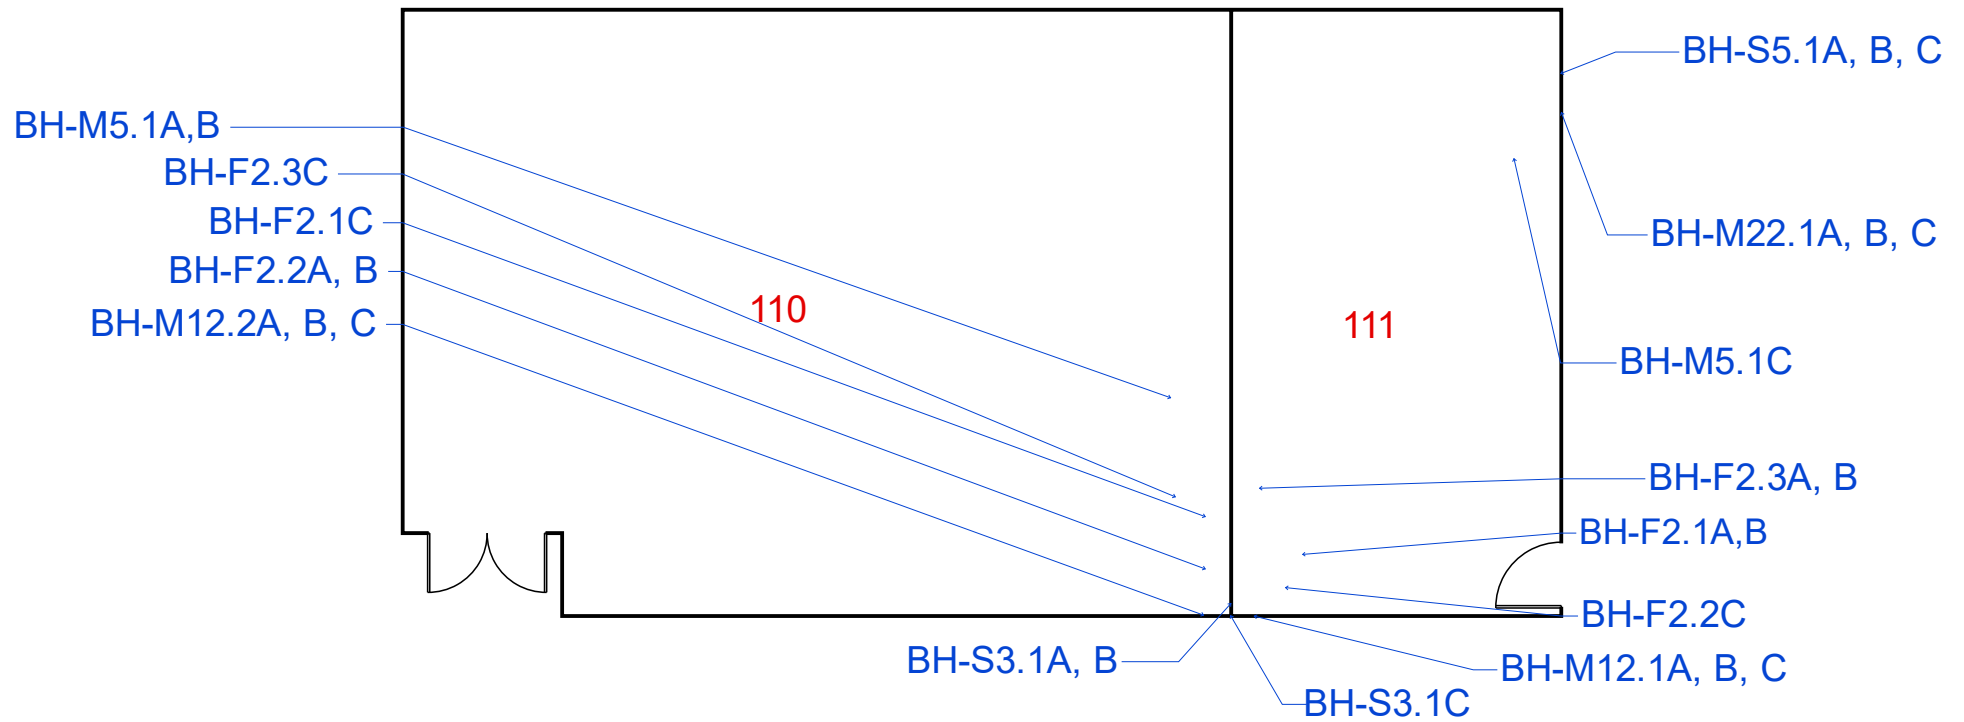
The bulk samples were shipped, along with the completed chain of custody (COC) documentation, to Crisp Analytical of Carrollton, Texas, for the analysis of asbestos fibers by polarized light microscopy (PLM) using U.S. Environmental Protection Agency (EPA) Methods described in 40 CFR Part 763 Appendix E Subpart E (Interim and EPA 600/R-93 / 116 (Improved)). A copy of the bulk asbestos laboratory analytical report and COC is provided in **Attachment B**. Approximate sample collection locations are provided in **Figure F-01**.

The following suspect ACMs sampled from the site were found not to contain asbestos by laboratory analysis:

- 9-inch by 9-inch blue vinyl floor tile and associated tan mastic located in Rooms 110 and 111 (BH-F2.1A, B, C)
- 9-inch by 9-inch tan vinyl floor tile and associated tan mastic located in Rooms 110 and 111 (BH-F2.2A, B, C)
- 9-inch by 9-inch red vinyl floor tile and associated tan mastic located in Rooms 110 and 111 (BH-F2.3A, B, C)
- 2-foot by 4-foot white with pinholes and fissured ceiling panels located in Rooms 110 and 111 (BH-M5.1A, B, C)

- 4-inch black vinyl cove base and associated tan mastic located in Room 111 (BH-M12.1A, B, C)
- 4-inch tan vinyl cove base and associated tan mastic located in Room 110 (BH-M12.2A, B, C)
- Green painted CMU block and gray mortar located in Room 111 (BH-M22.1A, B, C)
- Multicolored painted light orange peel textured wallboard system located in Rooms 110 and 111 (BH-S3.1A, B, C)
- White spray on fireproofing on metal roof decking located in Rooms 110 and 111 (BH-S5.1A, B, C)
